ENVIRONMENTAL SITE ASSESSMENT FOR THE EVALUATION OF POTENTIALLY HAZARDOUS MATERIALS

Vacant area 10, 305 Roandale Dr. Houston, Texas 77048

Prepared for
City of Houston
Building Services Department
P.O. Box 1562
Houston, Texas 77251

Attn.: Mr. Gabriel Mussio Date of the report: January 9, 2006

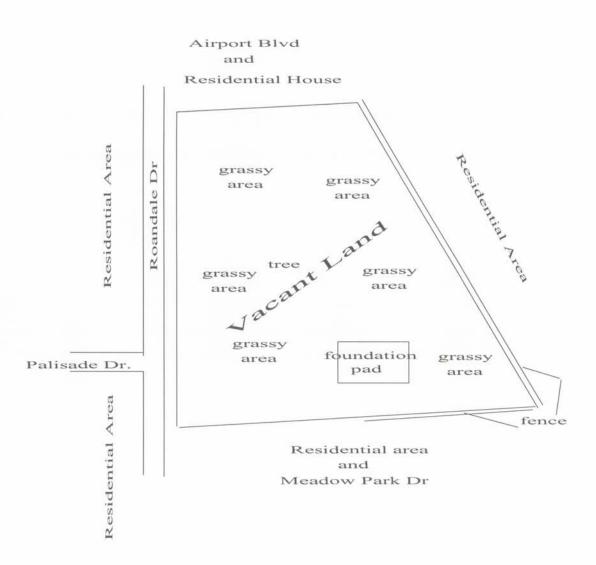
Figure1: Site map- 10305 Roandale Dr., Houston, Texas 77048

Figure is an approximation

Scale: 1" = 30 ft (approx.)

The site is geographically located at Latitude 29° 38' 49" and Longitude 95° 21' 08". A site map is presented as Figure-1.

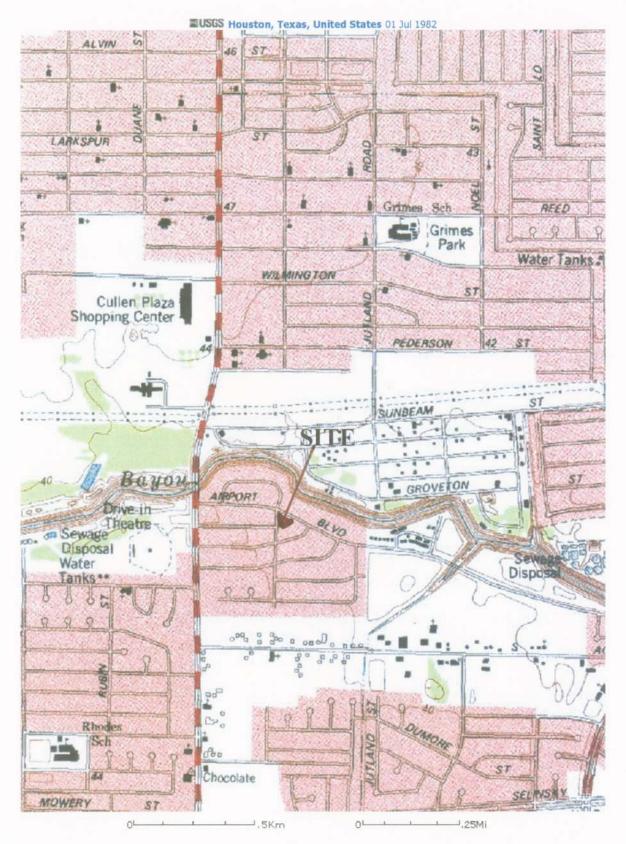
Topo Map

The elevation of the site is approximately 40 feet Above Mean Sea Level (AMSL) and can be seen on the Park Place Quadrangle Map. Nearest surface water feature is Sims Bayou. Surface water drainage is to the southeast.

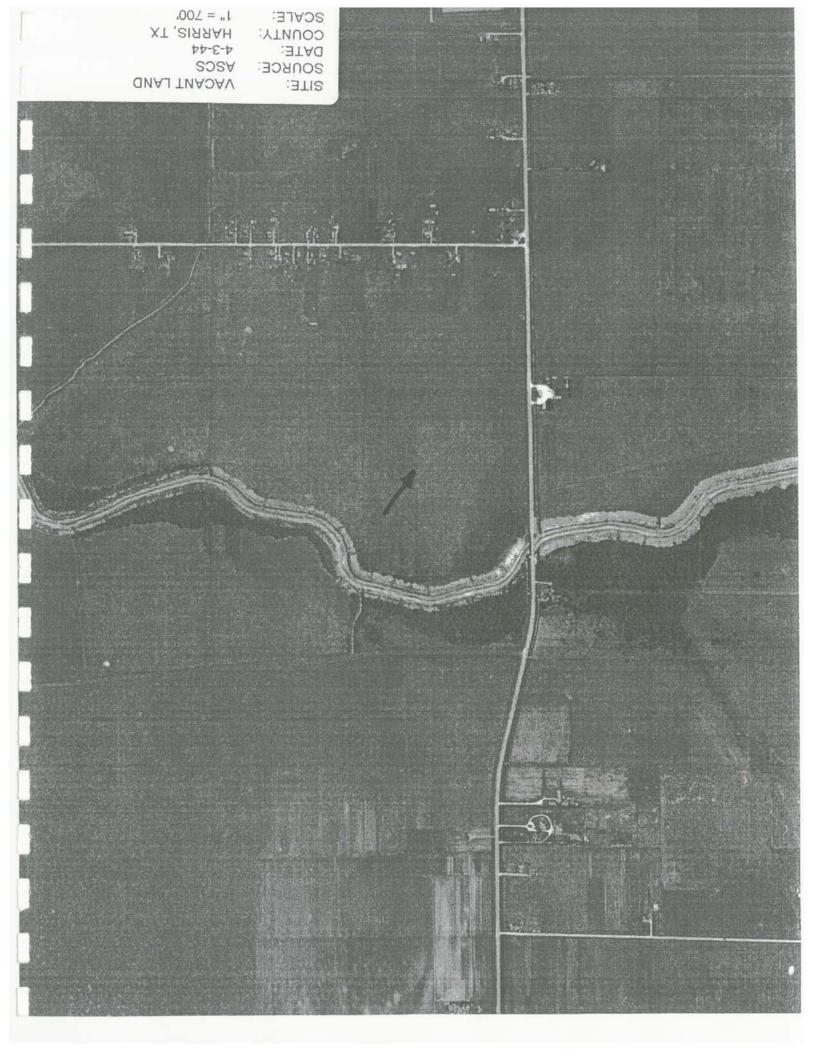
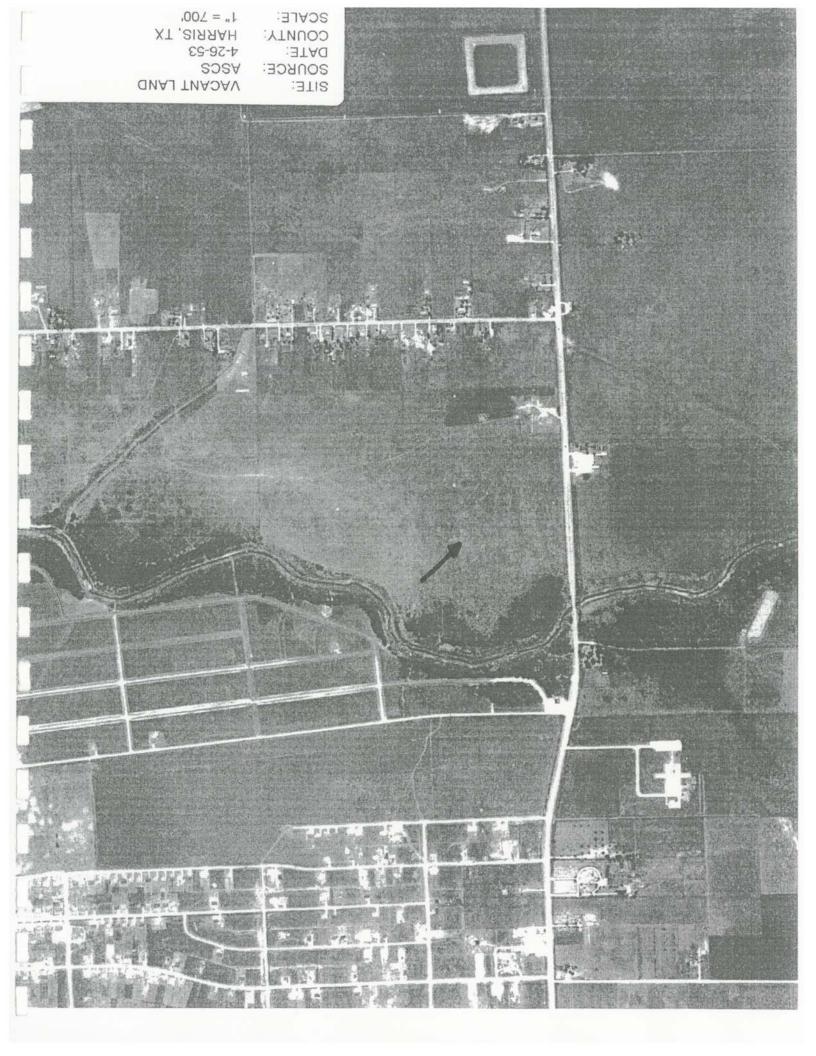
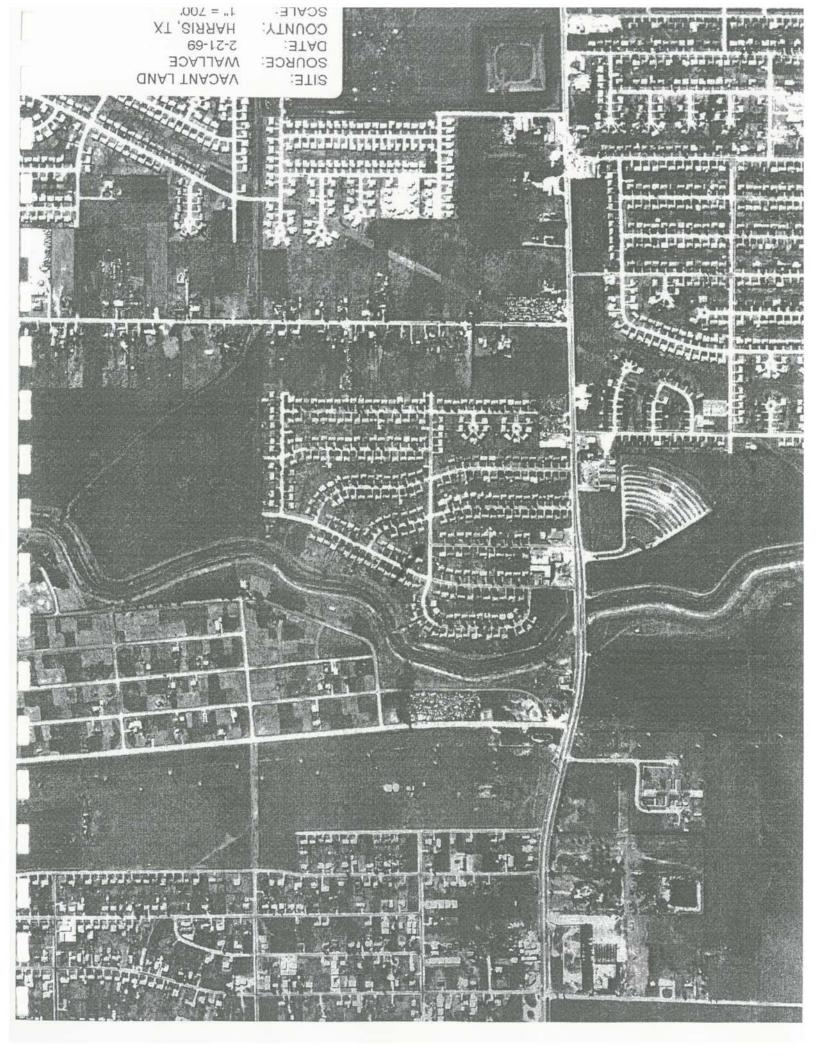
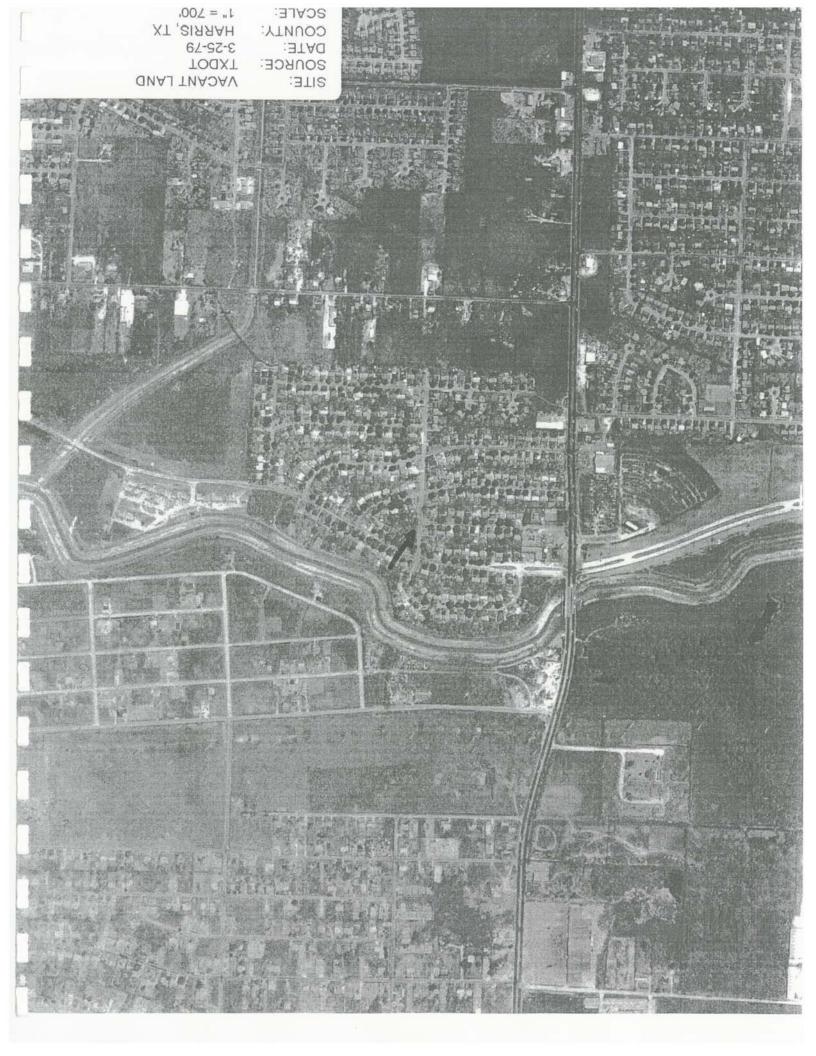
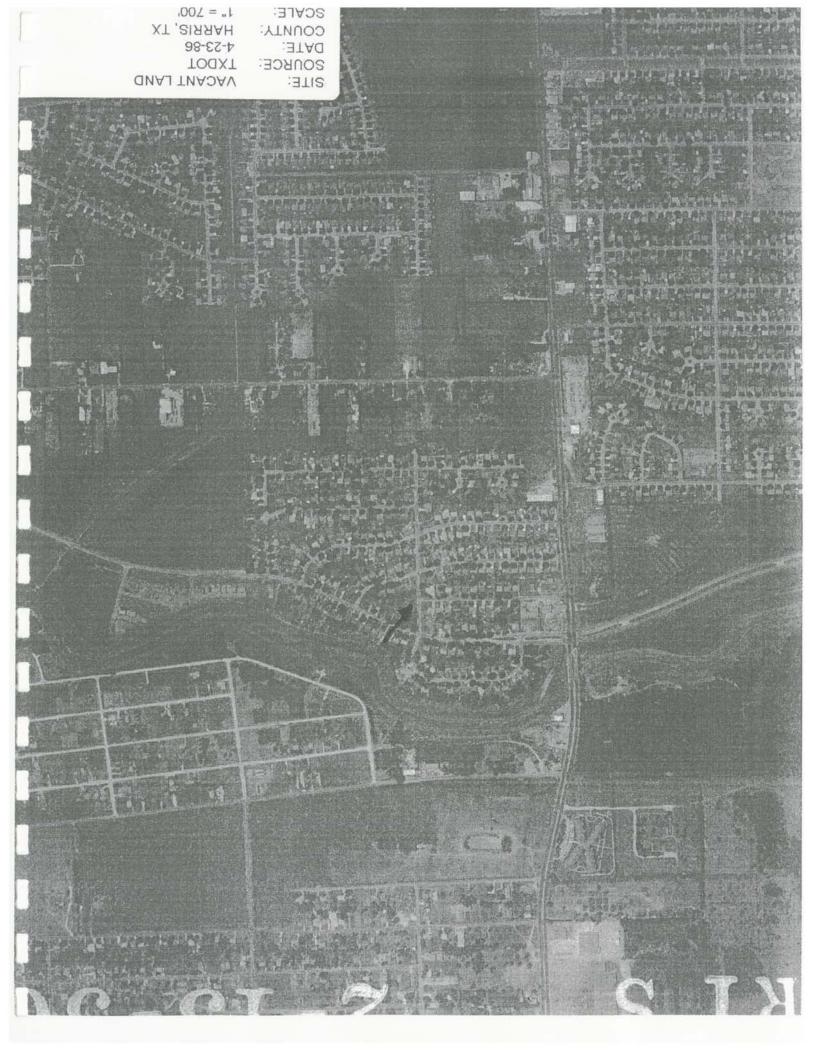
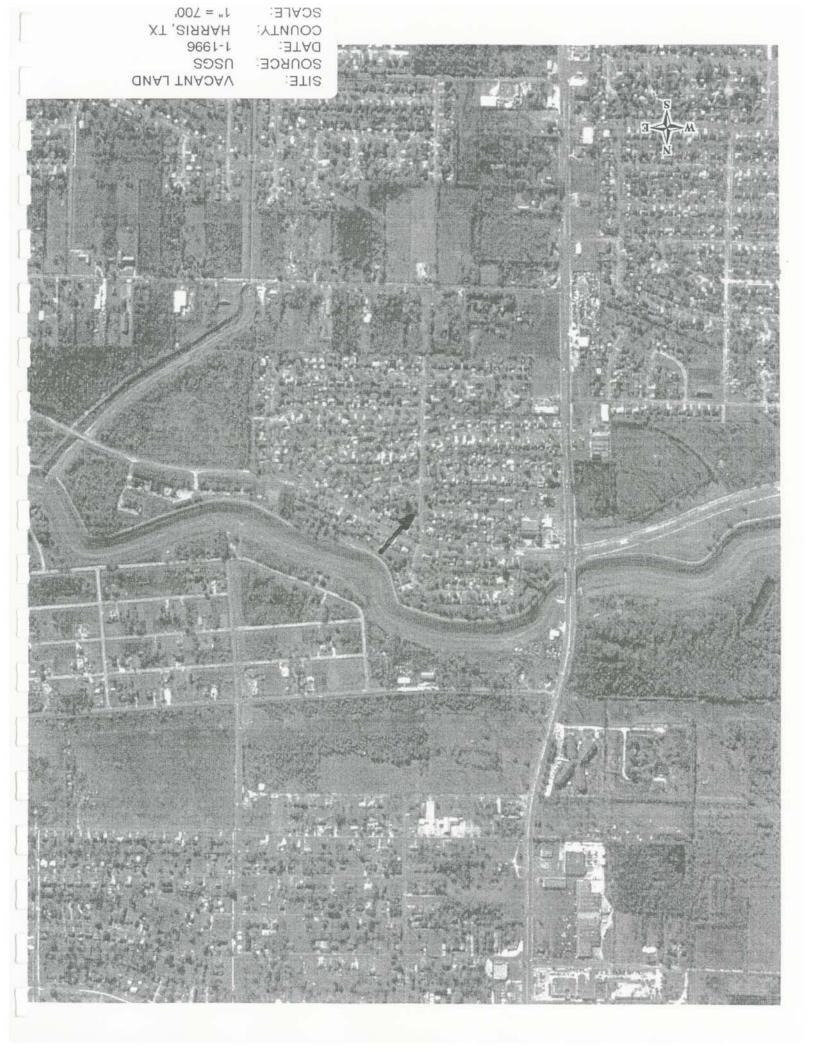
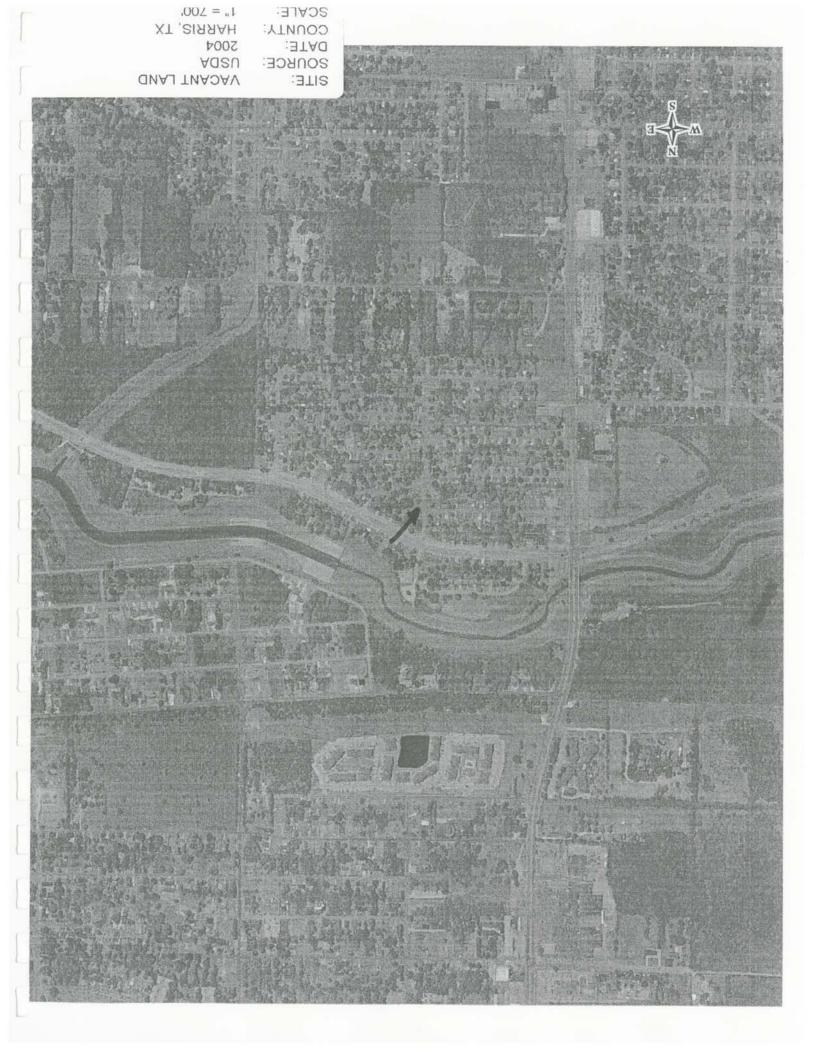
APPENDIX-D

1944 aerial photo (1"= 700') shows the site as a vacant land. Vacant and residential sites are present to the far north, south, east and the west.

1953 aerial photo (1"= 700') shows the site as a vacant land. Vacant and residential sites are present to the far north, south, east and the west.

1969 aerial photo (1"= 700') shows the site as a vacant land with a small building. Vacant, residential and commercial sites are present to the far north, south, east and the west.

1979 aerial photo (1"= 700') shows the site as a vacant land with a small building. Vacant, residential and commercial sites are present to the far north, south, east and the west.

1986 aerial photo (1"= 700 ') shows the site as a vacant land. Vacant, residential and commercial sites are present to the far north, south, east and the west.

1996 aerial photo (1"= 700') shows the site as a vacant land. Vacant, residential and commercial sites are present to the far north, south, east and the west.

2004 aerial photo (1"= 700') shows the site as a vacant land. Vacant, residential and commercial sites are present to the far north, south, east and the west.

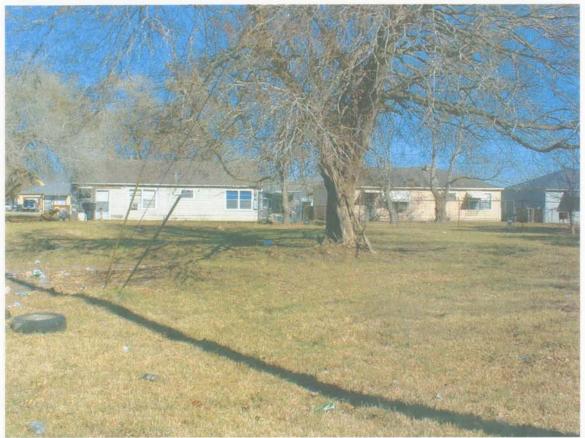
The subject property is a vacant land and is 7,289 square feet in area. The site has vacant, grassy areas, a tree and a concrete foundation pad of a former building. The site is legally described as follows:

Subject site

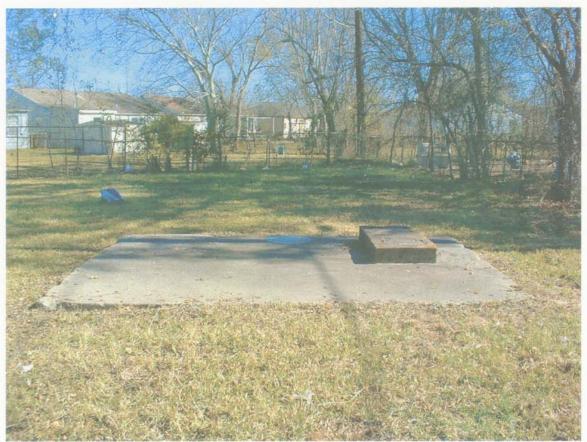
The subject property is a vacant land and is 7, 289 square feet in area. The site has vacant, grassy areas, a tree and a concrete foundation pad of a former building. Entrance to the site is from Roandale Dr. The foundation pad is present to the south of the site. The site has fence of residential houses to the south and east. No pipeline easement areas are present across and along the adjacent boundaries of the site. No other developments or improvements were found at the site.

Concrete foundation pad at the property
